Video Documentation Reveals Rusty Welds Early Fix Saves \$100,000+ in Repairs

Project Owner: *University of California,
San Francisco, CA*

Project: *Construct a solar canopy with 500 solar panels onto roof of 8-story parking structure and an array with 750 solar panels on the roof of the 4-story Genentech Hall parking structure.*

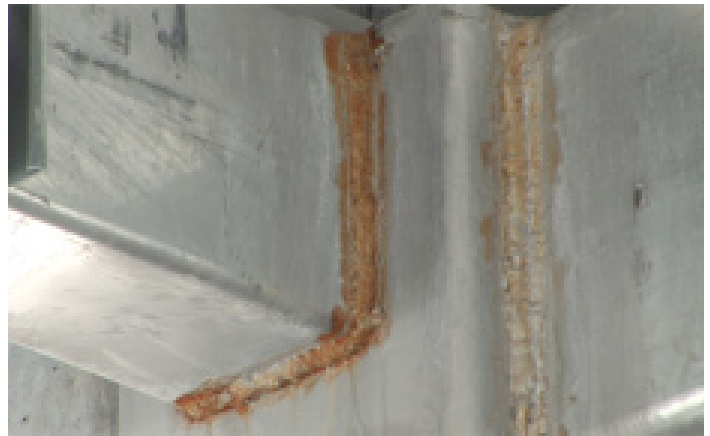
This 'galvanized' specification was discussed and incorporated into the steel subcontract. However, field video of the actual welding taking place showed a steel worker using a regular non-galvanized welding rod. The project manager made a note to inspect the welds closely at the next site visit.

By that time, the welds had been painted over. But because of what he had seen on video, the project manager got down on his hands and knees to take a closer look. He saw a few areas where the paint was already flaking away, a sure sign of incipient rust.

By the time paint starts peeling, rust has permeated the welds and penetrated the steel. The welds, which are critical for seismic support, must be replaced.

Any rusted steel has to be cut out.

If rust penetration is shallow, the steel can be patched with welding material inexpensively. But if penetration is deeper, entire sections of steel would have to be cut out and replaced with new steel. Depending on the extent of the damage, repairs could cost anywhere from \$100-250,000.

Further inspection and questioning revealed that non-galvanized welding had been used everywhere. Video was used to document all of the bad welds, hold the subcontractor accountable and bring the crew back for repairs.

The refit process was completed in one day. Had the rust not been caught early, the project manager estimates repairs would have taken about a month and cost \$100,000 minimum.
